CASE STUDY

Amber Property Services

Commercial Installations

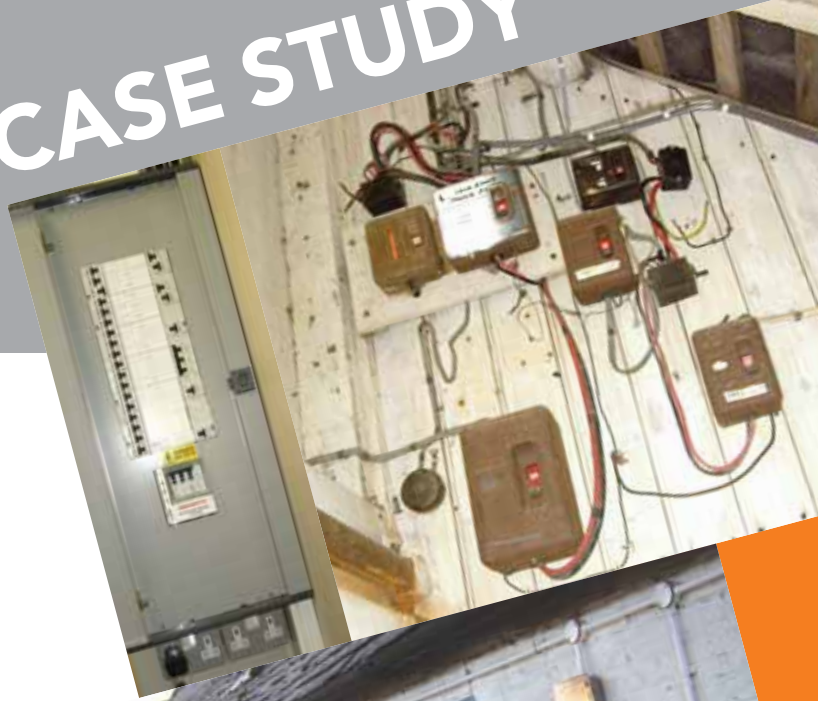
3-Phase fuseboards

A property consisted of many sub-main positions in an unsatisfactory condition. The scope of works entailed replacing cables with SWA style and connecting to one mains position proving single means of isolation.

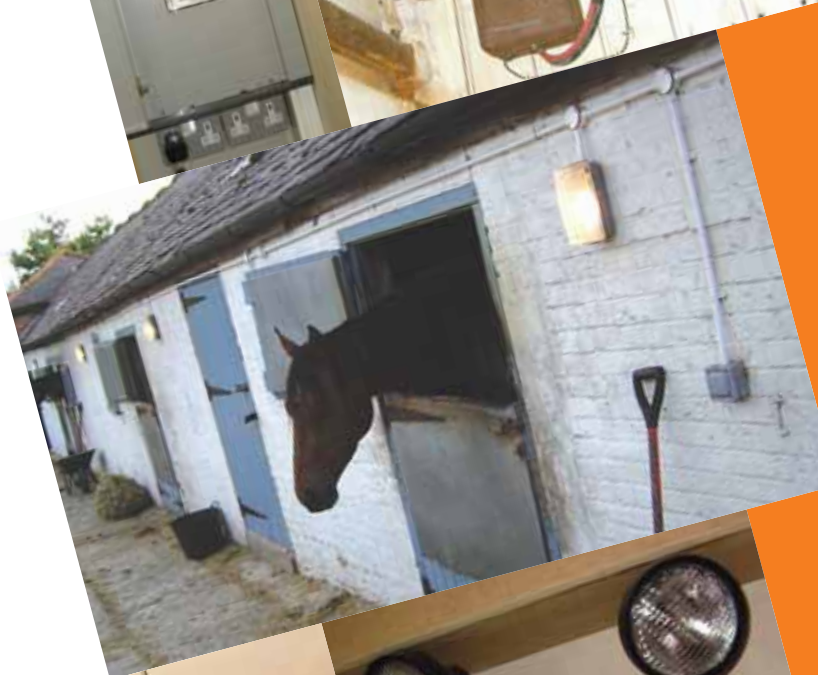
External lighting

A lighting system was installed to a stable block with pvc cables drawn into high impact conduit to give mechanical protection.

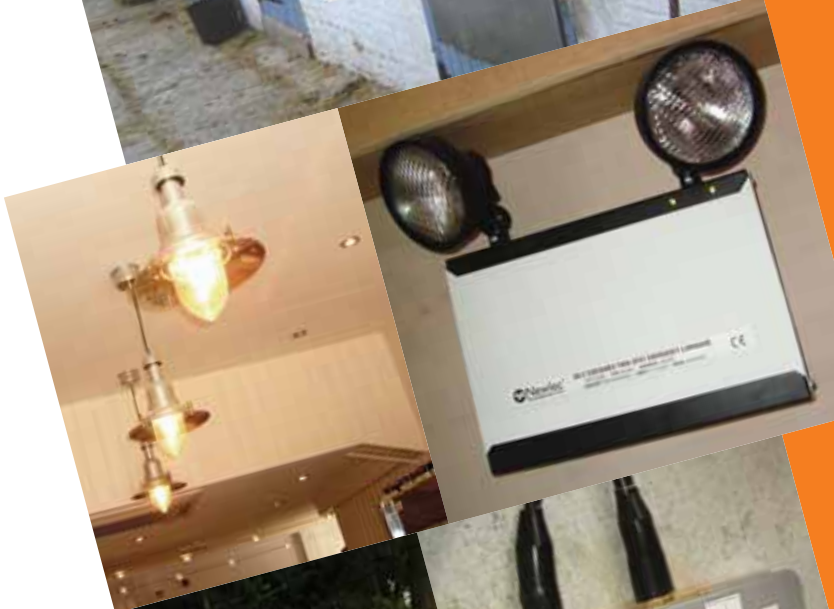
Internal lighting

During a restaurant refurbishment a revised lighting scheme was installed featuring recessed down lighters, and custom decorative lanterns to retain the character of the building.
